Construction News Report

**Student Academic
Services Building**

June 2008

**Lane Avenue
Parking Garage**

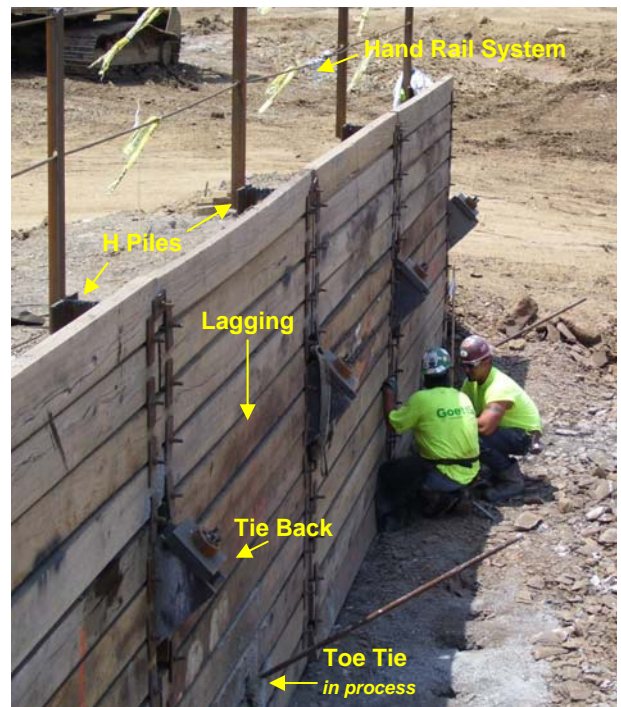
The installation of a utility tunnel across the site resulted in a shoring system that was designed specifically for this project. H Piles, lagging and tie backs are all part of the process to create a safe working environment for the tunnel construction crew.

H piles were first installed. These are large steel beams in the shape of an “H”. These beams were drilled into the bedrock and then grouted in place with high strength concrete.

Lagging is a wooden structure that was attached to the H piles. These wood beams hold back dirt and prevent collapse of the exposed wall.

Tie Backs and Toe Ties are steel cables that were installed to the H piles and lagging to provide additional strength to the system. The toe ties are designed to keep the bottom of the H pile and lagging from being pushed out at the bottom due to the force of the earth on the back side of the wall.
